# Get It Right the First Time

## A Case Study on Monitoring-based Commissioning for New Construction

Presented by B2Q Associates, Inc.

UMass Amherst  
Physical Sciences  
Building

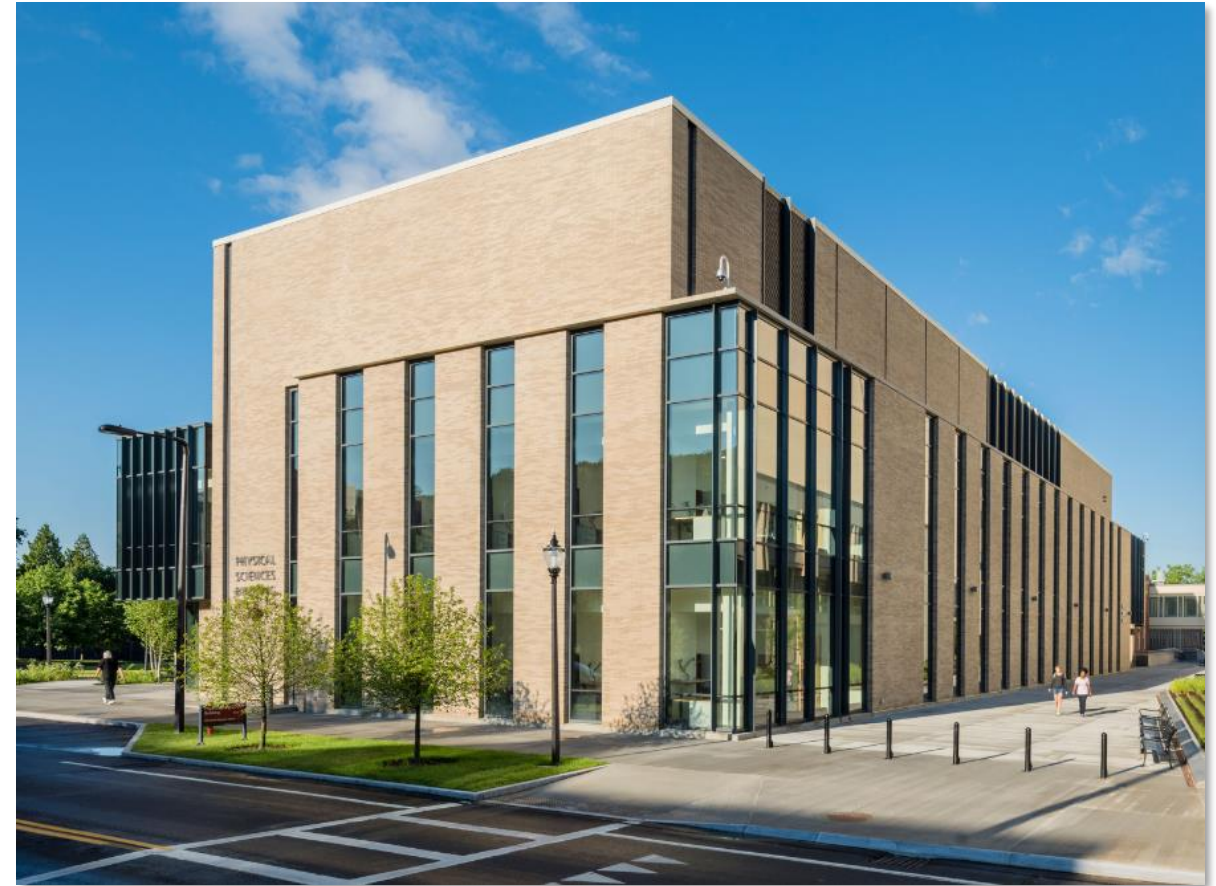
# Case Study: UMass Amherst Physical Sciences Building

- **90,000 GSF**
- **20 faculty-led research groups**
- **3 make-up air units with heat recovery**
- **47 lab zones**
- **90 fume hoods**
- **Initial occupancy in spring 2018**
- **Warranty period through May 2019**
- **LEED Gold Certified**

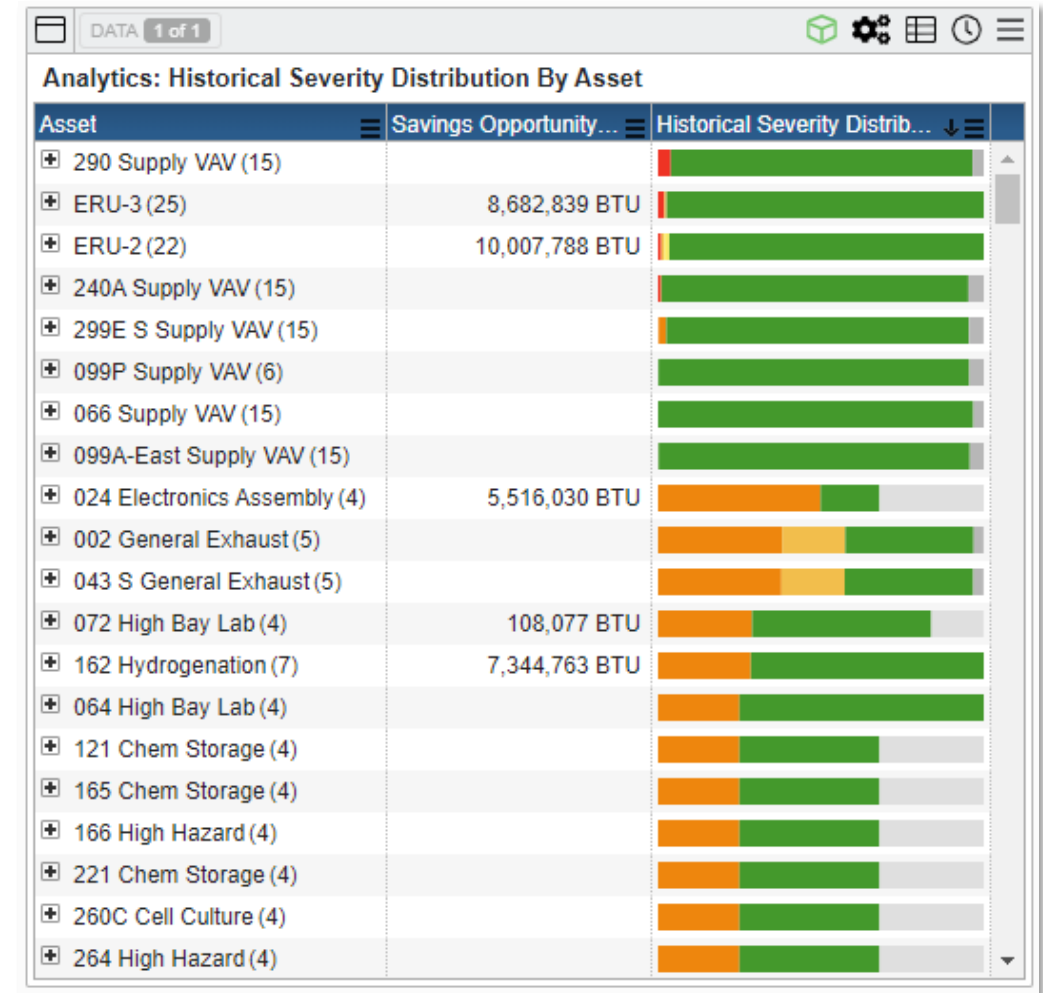
### Initial Results - 43 Unique Issues

- 10 of 47 labs (21%) with improper pressurization
- 6 Labs operating well above design min ACH
- Broken fume hood sash position sensors
- Valve and damper hunting
- Broken communication between lab controllers and supervisory controllers – ‘flat lined’ points
- Inefficient ERU heat recovery control

**Most classified as issues covered under warranty**

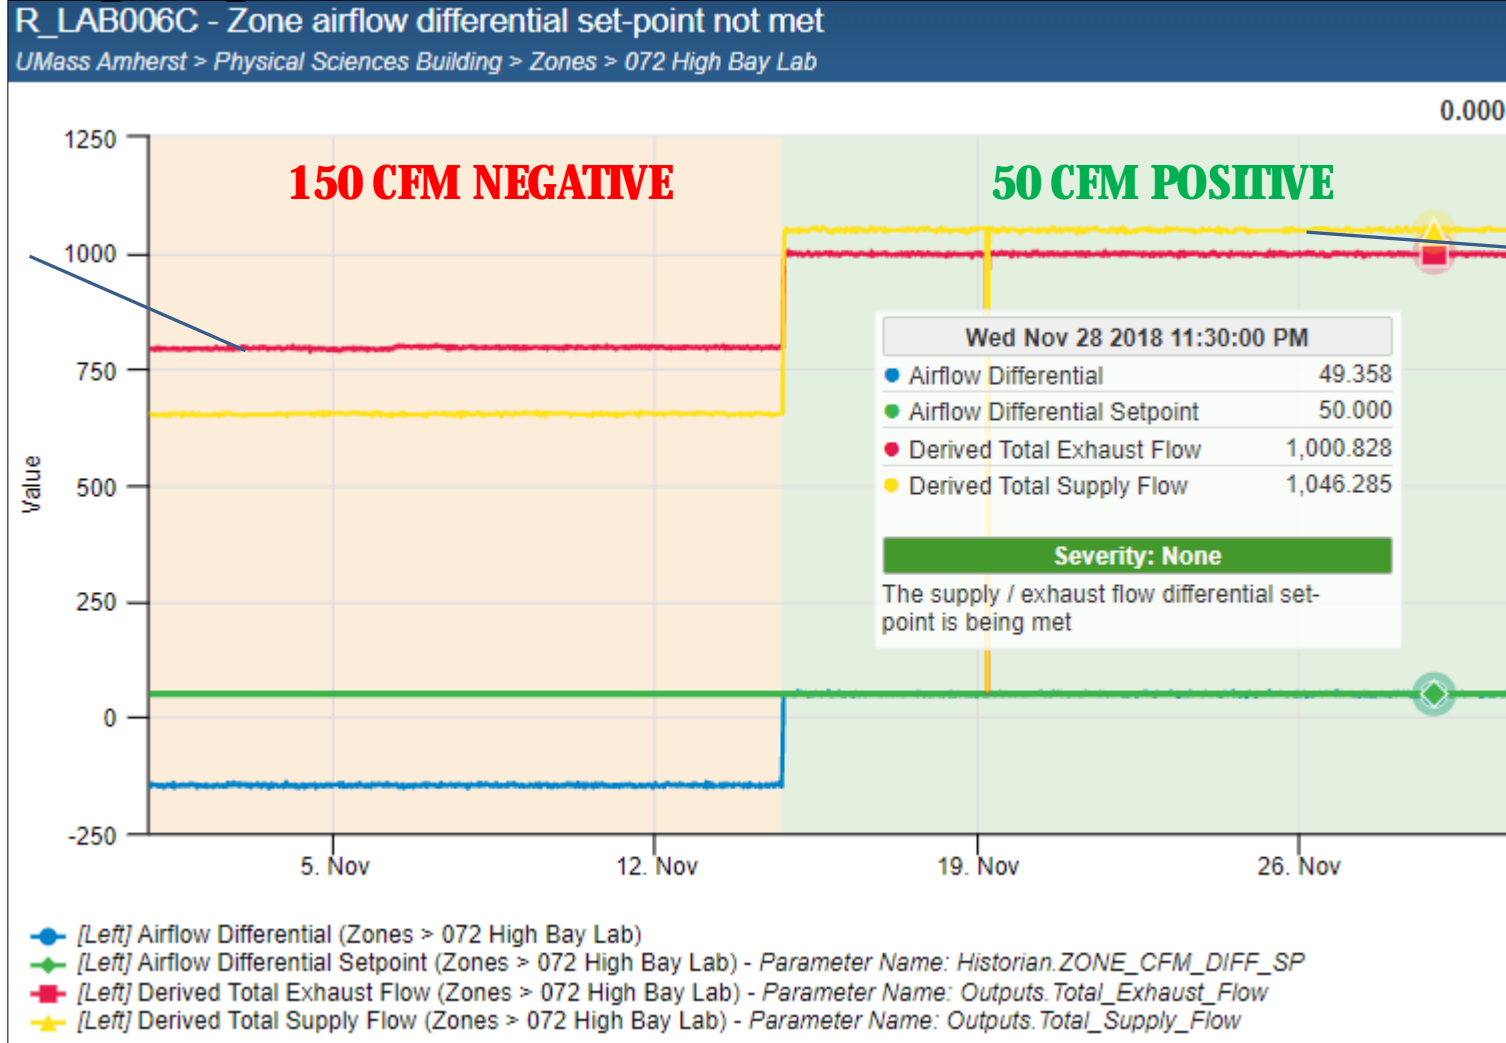
# Case Study: UMass Amherst Improper Lab Pressurization – Clean Room

Exhaust Flow: 775 cfm  
Supply Flow: 625 cfm

Exhaust Flow: 1,000 cfm  
Supply Flow: 1,050 cfm

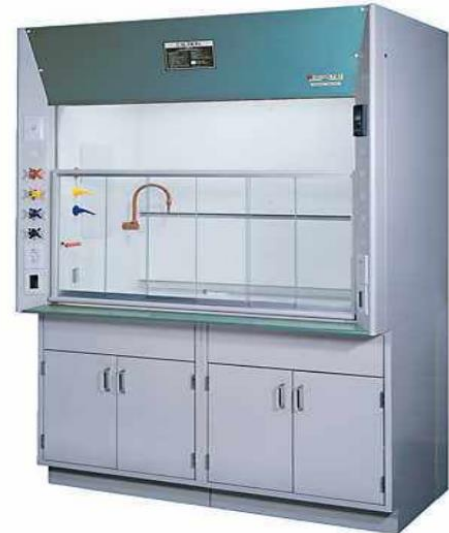
# Case Study: UMass Amherst Failed Fume Hood Sash Sensor – High Lab ACH

**Hood Sash Sensor  
Disconnected**

SASH-POS	LOEXHFLW-ALM
000.0 %	Normal
SASH-ALM	EXH-DPR
Normal	81.9 %
FACEVEL-SP	EXHDPR-FE
810.0...	82.7 %
FACE-VEL	PHPURGE-ALM
0.0 ft/min	UPS
LOFACEVEL-ALM	RMPURGE-ALM
Normal	UPS
EFFEXHFLW-SP	ALM-8
810.0 cfm	Normal
EXH-FLW	DI-BITMASK-8
806.6 cfm	33202-0...

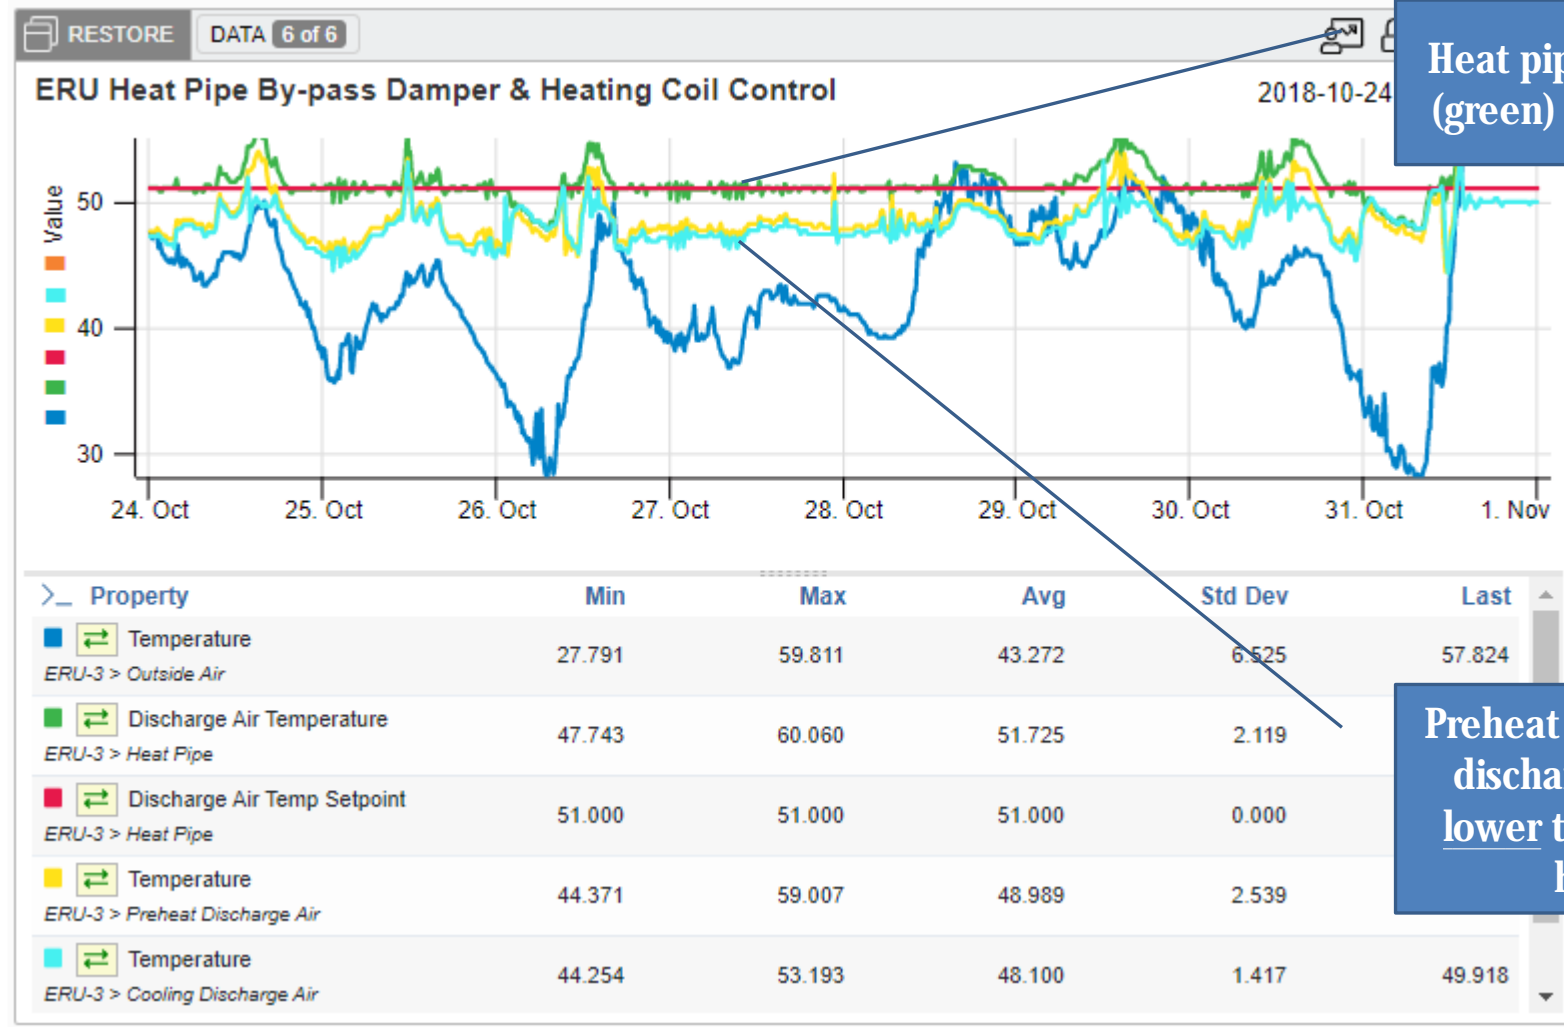
# Case Study: UMass Amherst Ineffective Energy Recovery Unit Heat Pipe Operation

Heat pipe leaving air temperature (green) meeting set-point of 51°F

Preheat (yellow) and cooling (red) discharge air temps both 4-5°F lower than heat pipe temp with heating valve open
